Participatory inspection and assessment of Otji-toilets in Grundorn South and Nico Noord, Hardap region

By the
E-CAP project

Desert Research Foundation of Namibia, June 2012

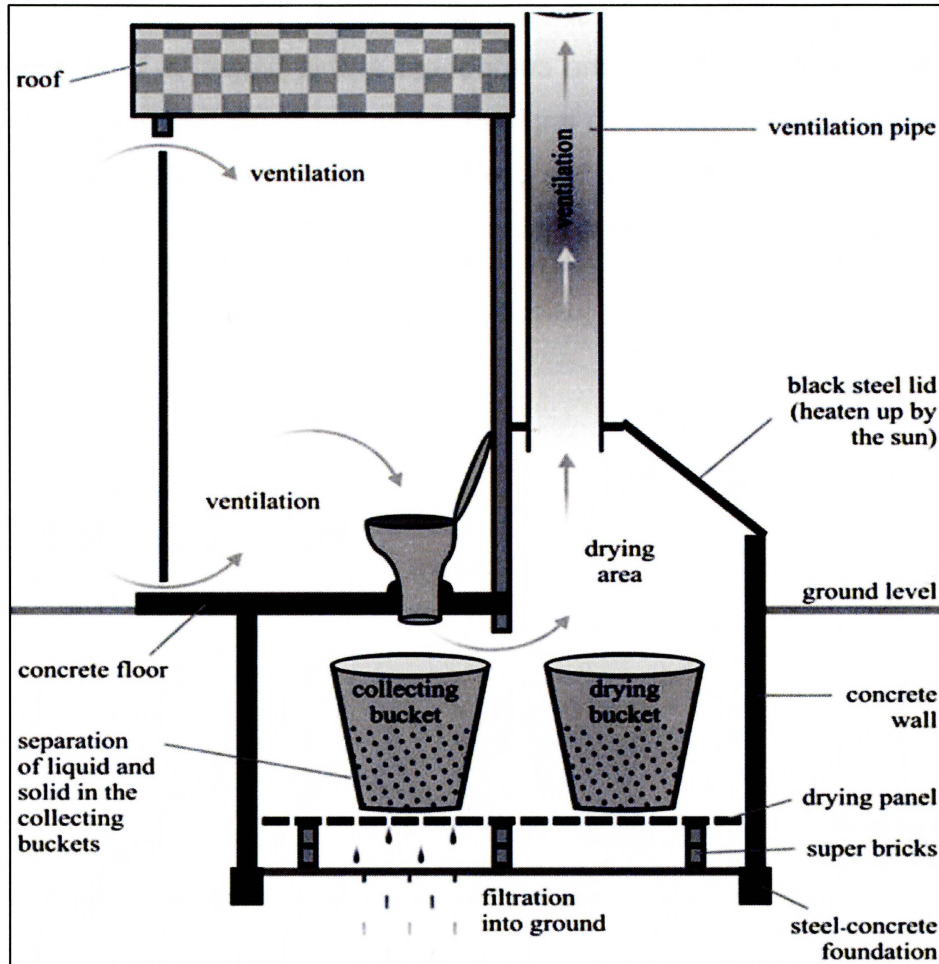
Figure 2: Sketch of Otji-toilet

The Otji-toilet is a dry sanitation system, i.e. a toilet that does not require any water for its operation. The Otji-toilet has two waste buckets, ^{drum} one bucket is used for collection of human waste and the second bucket is the drying ^{drum} bucket. Once the collection ^{drum} bucket is full, it is shifted behind to dry and the second collection ^{drum} bucket is put under the toilet pot. In order to prevent odour and speed up the drying process, the Otji-toilet is fitted with a ventilation pipe. A black steel lid (which is facing north for maximum exposure to the sun) covers the drying ^{drums} buckets, resulting in increased temperature in the drying chamber which speeds the drying process. The Otji-toilet can either mix the urine with the waste or be fitted with a Urine Diversion System (UDS), which separates 95% of urine from the waste. The urine is collected ^{at pipe} in the pot and transferred from the toilet ^{by a pipe} into a French drain (a bed of gravel and stones) using ~~a pipe~~.

the urine is drained from the bottom of the collection ^{drum} bucket, penetrating through the holes of the drying plate and infiltrating into the soil (Figure 2).

As part of the questionnaires a sketch of the Otji toilet (Figure 2) was used. Broken parts of the toilet were marked on the sketch.

The drying plate is placed at the bottom of the drying chamber, forming the floor on which the collection drums are placed. The black steel screws are used to screw/tighten the black lid that covers the chamber behind the toilet (Figure 2). The iron rods are used

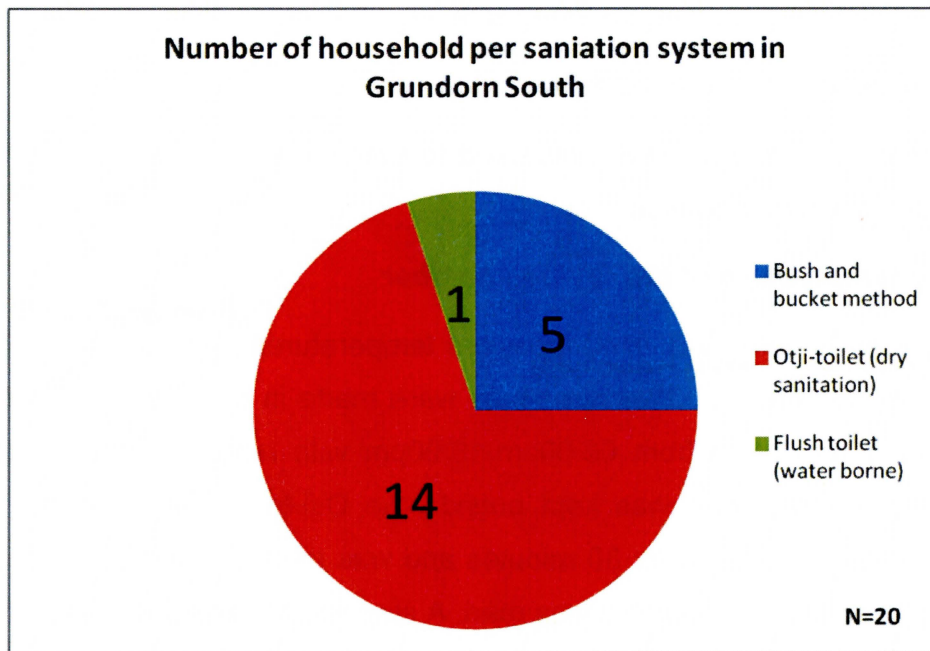
Figure 3: Sanitation systems in Grundorn South

In Grundorn South all 20 households were interviewed. The sanitation systems used by these households are: bucket and bush, ~~dry sanitation (Otji-toilet)~~ Otji-toilet and flush toilet. The numbers of interviewed households using these different types of sanitation systems are presented in Figure 3. ^{At least} 14 households indicated that they use the Otji-toilet, while there are only 11 Otji-toilets in Grundorn South. ^{and this was observed} Two of the Otji-toilets are shared amongst two and three households each, while individual households use nine of the Otji-toilets. ^{Grundorn} Four of the 11 Otji-toilets in Grundorn South have UDS. Five households use a combination of bush and buckets and one household has a flush toilet. The household with the flush toilet is experiencing problems with the septic tank as the septic tank is full and has started to overflow.

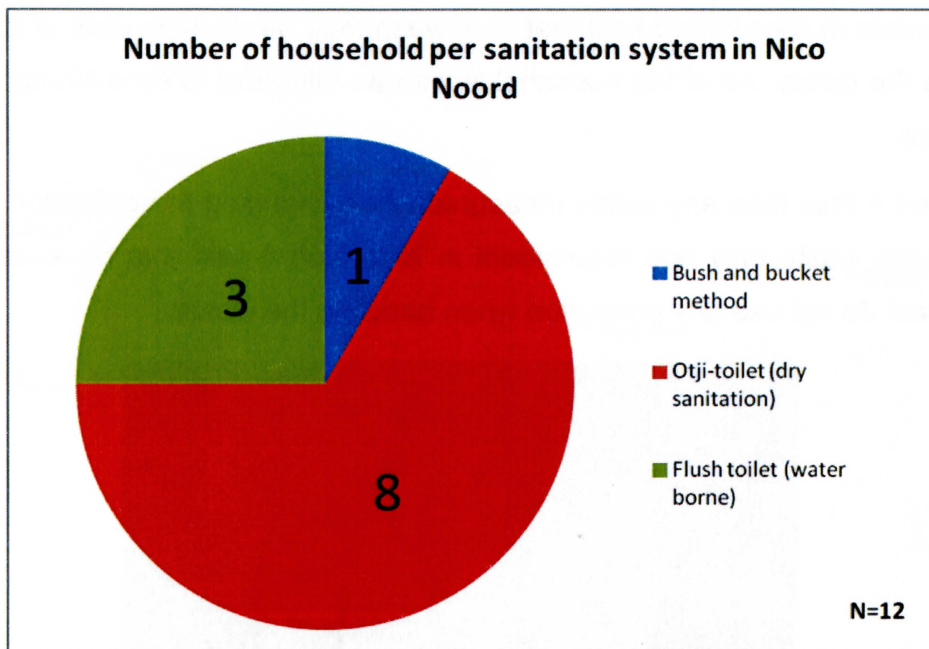
Figure 4: Sanitation systems in Nico Noord

In Nico Noord 12 households were interviewed. The existing sanitation systems used by these households are: bucket and bush, Otji-toilet and flush toilet. There are six Otji-toilets used by eight households. Two households share two of the toilets. The household that uses bucket and bush is currently constructing an Otji-toilet, provided by the E-CAP project. Currently that household is emptying the waste ^{from the bucket} into the nearby riverbed. ^{in Nico Noord} Two of the Otji-toilets have UDS.

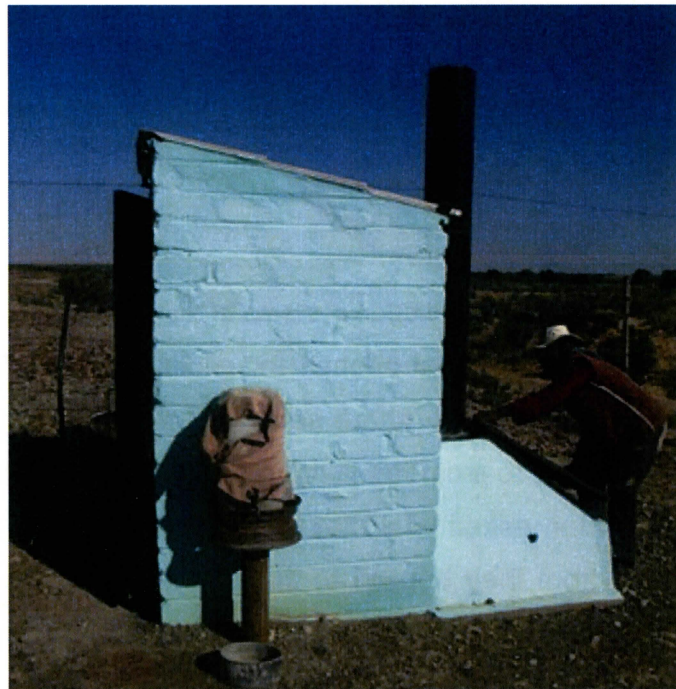
Figure 5: Homemade hand washing facility ^{outside} at an Otji-toilet in Grundorn South

According to the interviewees in Grundorn South, they all wash their hands after using the toilet. After using the toilet they wash with water from either taps behind or in front of their houses or in a bucket situated next to the house. One household has constructed a hand washing facility made out of a 25 litre plastic container ~~turned upside down and~~ *outside* fixed with a tap. The container is attached *to* the toilet (Figure 5). Even when used by the eight family members, the 25 litres of water can last as long as a month. The inspection of the toilets shows that the Otji-toilets are kept clean and in working order by the users.

Households that don't have access to a tap in their yard use buckets for washing their hands. The initiative taken by one of the interviewees to construct a hand washing

facility at the Otji-toilet is very innovative and something that should be replicated wherever there is a need for improved hand-washing facilities.

- Hand washing facilities should be installed on these toilets as a way to promote health and hygiene and
- Awareness about health and hygiene should be created in these farms through participatory community meetings, and development of brochures and posters.

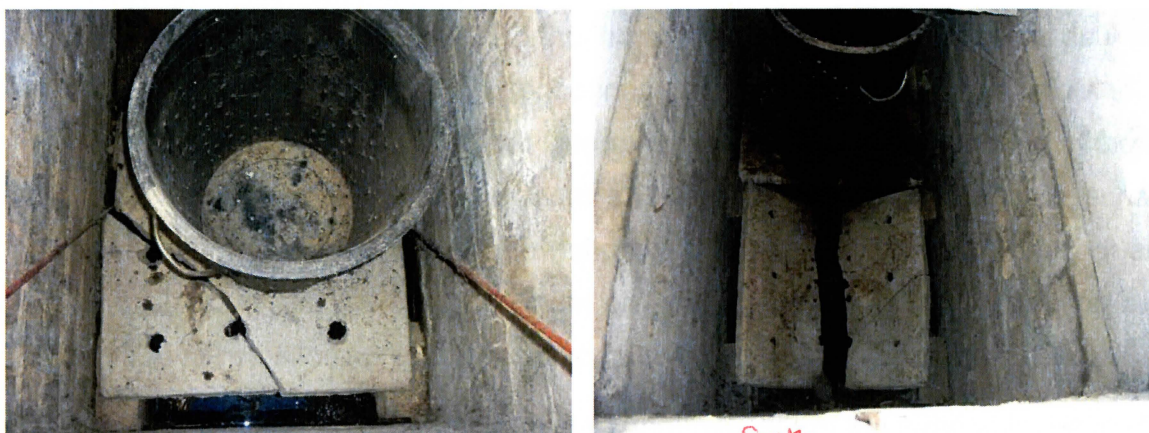
Figure 5: Broken drying plates in Grundorn and Nico Noord

The inspection of the 17 Otji-toilets revealed that the physical structures are still in good condition in both Grundorn South and Nico Noord. The most frequent problem is that the corners or the middle of the drying plates are cracking (Figure 6). Of the 17 Otji-toilets, 6 had cracked drying plates. Other observed damages of the Otji-toilets are presented in Table 1. Some households did not make any attempt to fix the damages on their toilets as they believed that it was the project's responsibility to do maintenance on the Otji-toilets even though when the toilets were handed over to the beneficiaries in 2011, it was clearly stated that the maintenance of these toilets is the responsibility of the beneficiaries/owners.

During inspection of all the 17 dry sanitation systems most toilets were in good condition with slight or no smell and were kept clean by the owners. The biggest problem was the breakage of the drying plates on which the ~~waste~~^{collection} drums stand. According to the interviewees the drying plates broke when switching the full drums. In response to this problem two households of the total eight ~~waste~~^{collection} drums that have filled in both Grundorn South and Nico Noord have decided to now switch the drums before they are full.

- Temperature (thermometer) readings should be done for different seasons on more than one Otji-toilet on each farm to get representative results.
- To avoid drying plates breaking the plates should be made stronger or alternatively more bricks could be put under the plate.

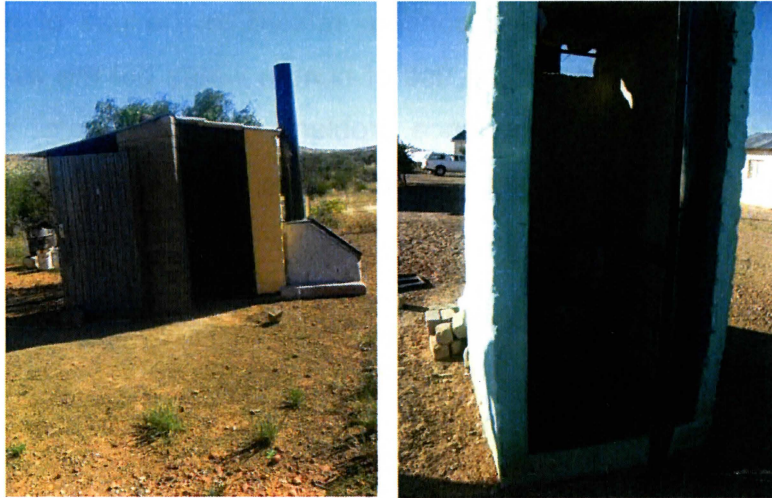
Figure 6: Left: Otji-toilet with a shower. Right: Otji-toilet with tiles

Most households have not made any improvements or adjustments to the toilets, except for two households in Grundorn South where floor tiles were added for decoration purposes and to prevent reptiles such as snakes. In Nico Noord a shower has been constructed next to an Otji-toilet (Figure 7). The respondents also raised concern about the spaces between the door frames which allowed access to reptiles because at one household in Nico Noord a live snake was found in the drying chamber of the Otji-toilet ~~and was killed on the spot.~~

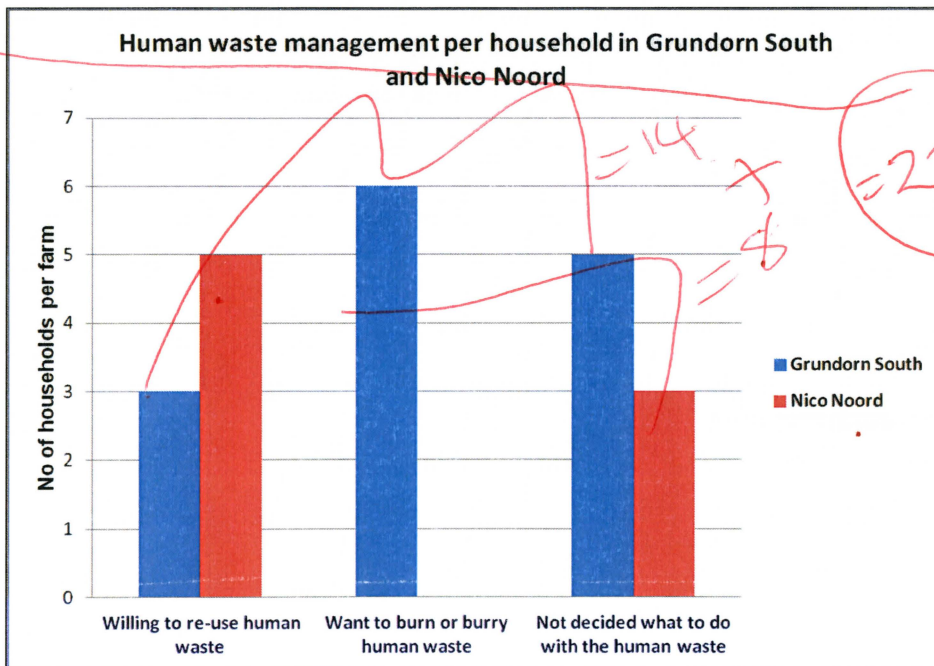
Figure 7: Human waste management decisions in Grundorn South and Nico Noord

Of the 32 interviewees, ^{Grundorn & Nico} eight are willing to re-use the human waste from the Otji-toilets. The remaining households said they would prefer to burry or burn the waste together with the animal waste. Eight of the interviewees have not yet decided what to do with the human waste when both drums are full (Figure 9). One interviewee in Nico Noord is already using the waste as compost for his onion and tomato garden as well as for the plants. The human waste was mixed with animal waste.

- Training of re-use of human waste as compost for gardening should be introduced as most of them said they did not have knowledge to do so and thorough research is conducted on re-use of human waste for compost.

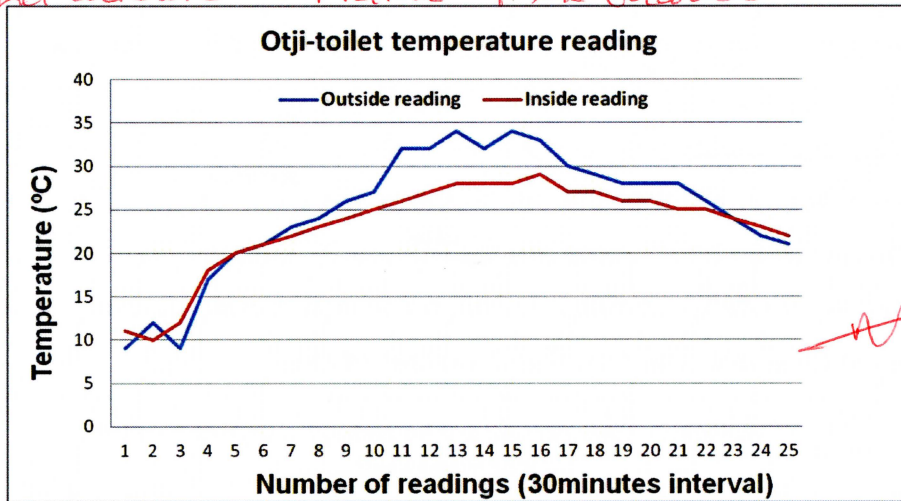
Figure 8: Otji-toilet temperature reading in Nico Noord

The reason for the recording of the temperature was to be able to compare the temperature inside the Otji-toilet chamber where the drying drums are kept and the outside temperature.

in order to see how quickly the waste dry out before disposal. Figure 8 depicts the difference in waste and outside temperature of the chamber.

Temperature readings taken in one Otji-toilet in Nico Noord, indicated that the outside of the Otji-toilet chamber was warmer compared to the inside of the chamber even though from the beginning the inside was warmer but dropped during the day. The Otji-toilet black steel lid is designed in a way that it should direct more heat inside the chamber where the drying ^{drum} bucket is kept to speed up the drying process of the human waste in the drying bucket but this was observed otherwise according to the temperature readings conducted. The reason for the lower temperature in the chamber compared to the outside air might be the time of the year, with cold nights and warm days. It is likely that the temperature in the chamber is more even, varying less than the outside air temperature during the colder months. On the other hand, during the warm summer months the situation might be reversed. It is likely that the waste takes longer to dry during the cold winter months compared to the warmer summer months. This still has to be further investigated.
