Rammed earth and clay testing at Gobabeb

NOVEMBER 1997

D.R.F.N.	Report 2
REFERENCE:	1179
LIBRARY:	WHK

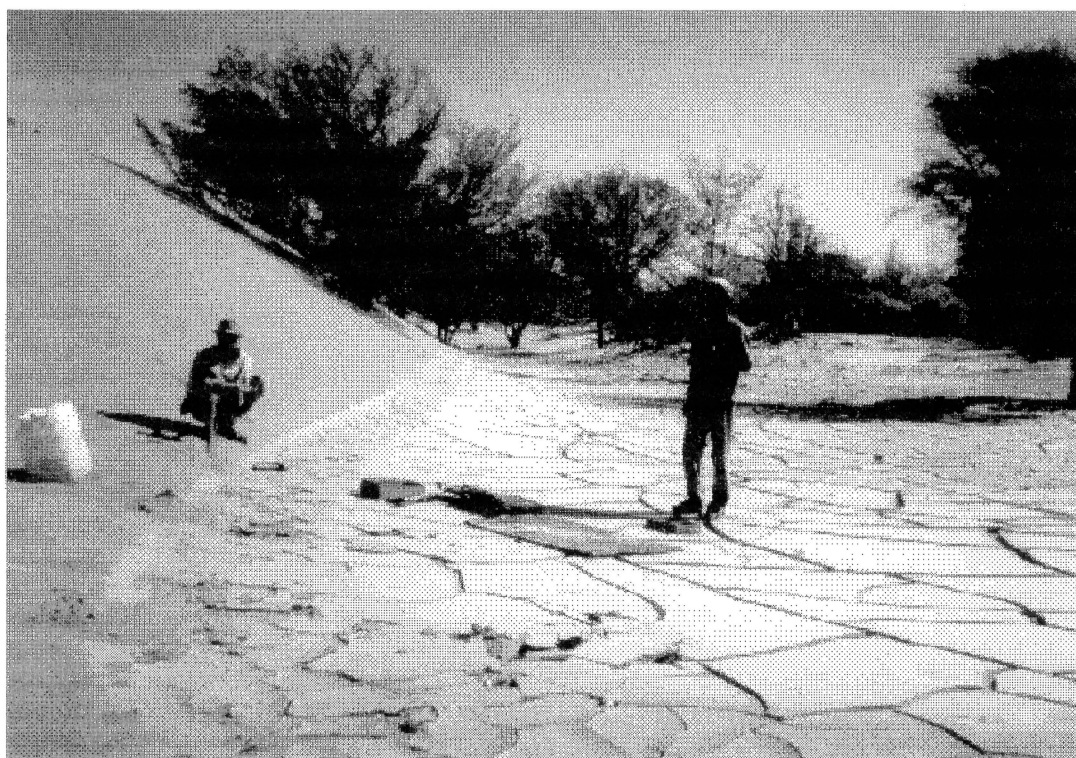
Figure 1: Daniel and Francisco at one of the clay testing sites within the Kuiseb riverbed. Note the 'caked' nature of the clay
